# Thermographic Inspection of Tank-Car Thermal Insulation

Transport Canada  
Safety and Security  
Transportation Development Centre

A. M. Birk Engineering  
Kingston, Ontario

March 1998

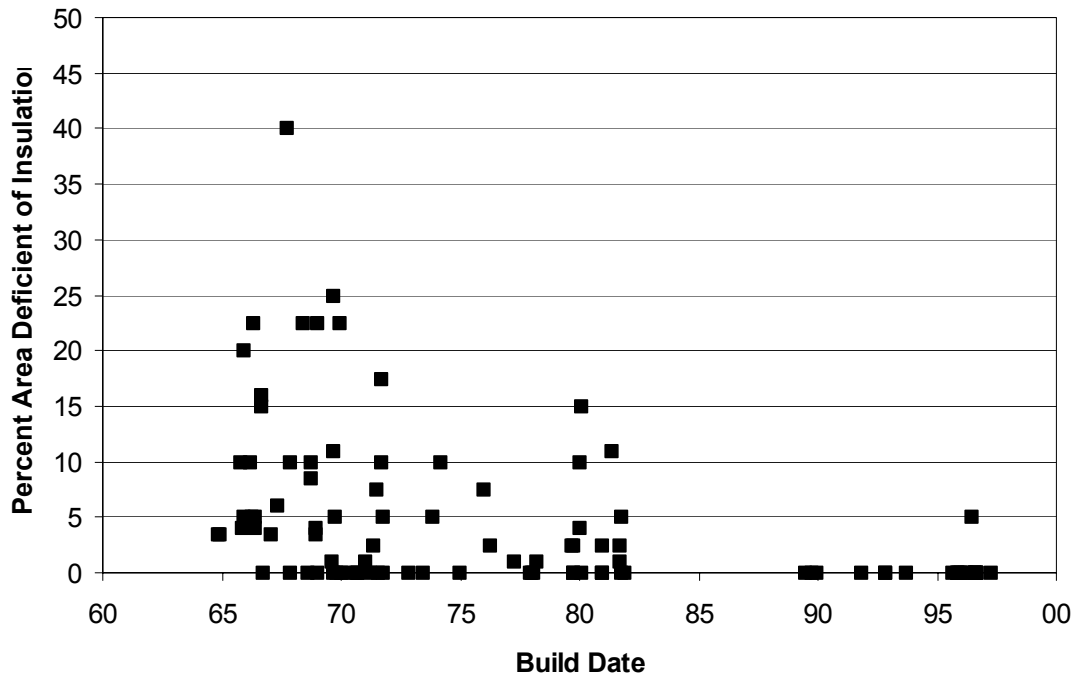
**Figure 5: Area of insulation deficiencies on one complete side of tank cars by tank car age (Sarnia field test)**

for tank cars greater than 20 years old, the number and severity of insulation deficiencies greatly increase.

If tank cars greater than 20% deficient in insulation are considered to be critical, Figure 8 shows that approximately 20% of tank cars greater than 30 years old have greater than 20% areas of deficiency, 10% of tank cars 20-30 years old have this level of deficiency, and very few tank cars younger than 20 years have levels of deficiency this great.
